These photos were taken the day after a June 2002 rain event. It had stopped raining but water was still running from the higher St. Edward's elevations northbound to St. Edward's Drive and flowing over the street.

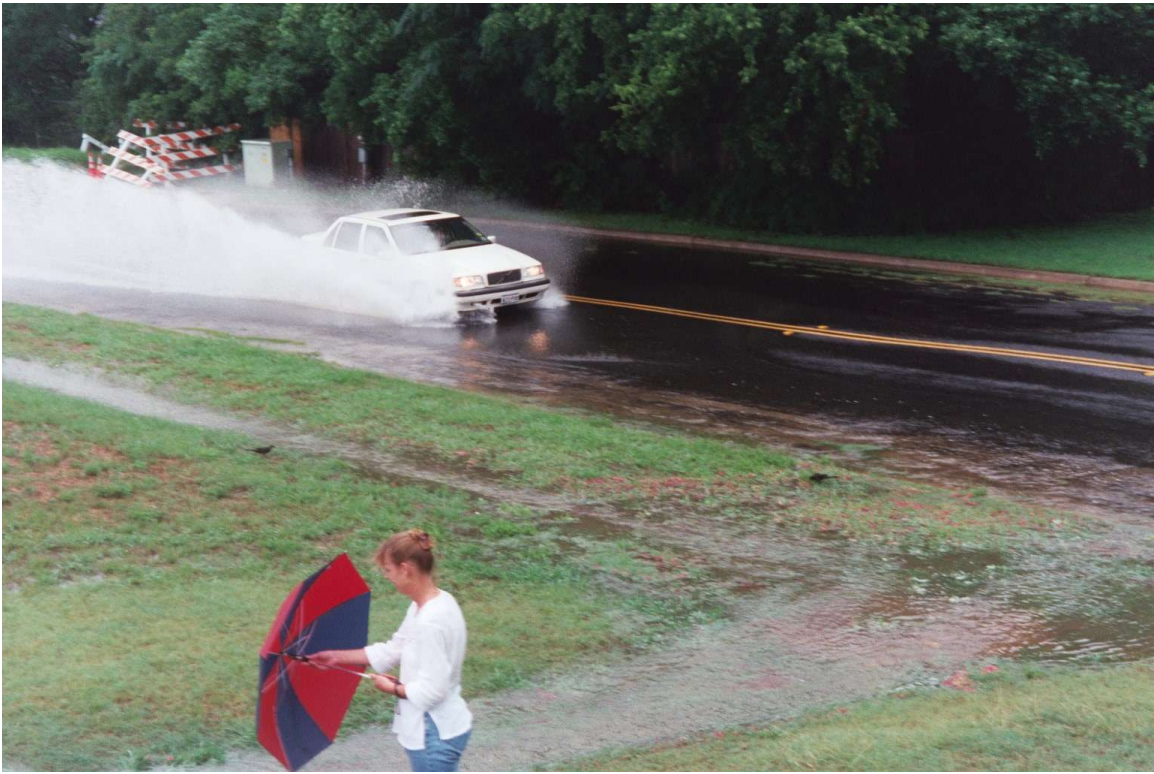
Note that in some of these photos the cars are swerving to avoid deep water in the road.

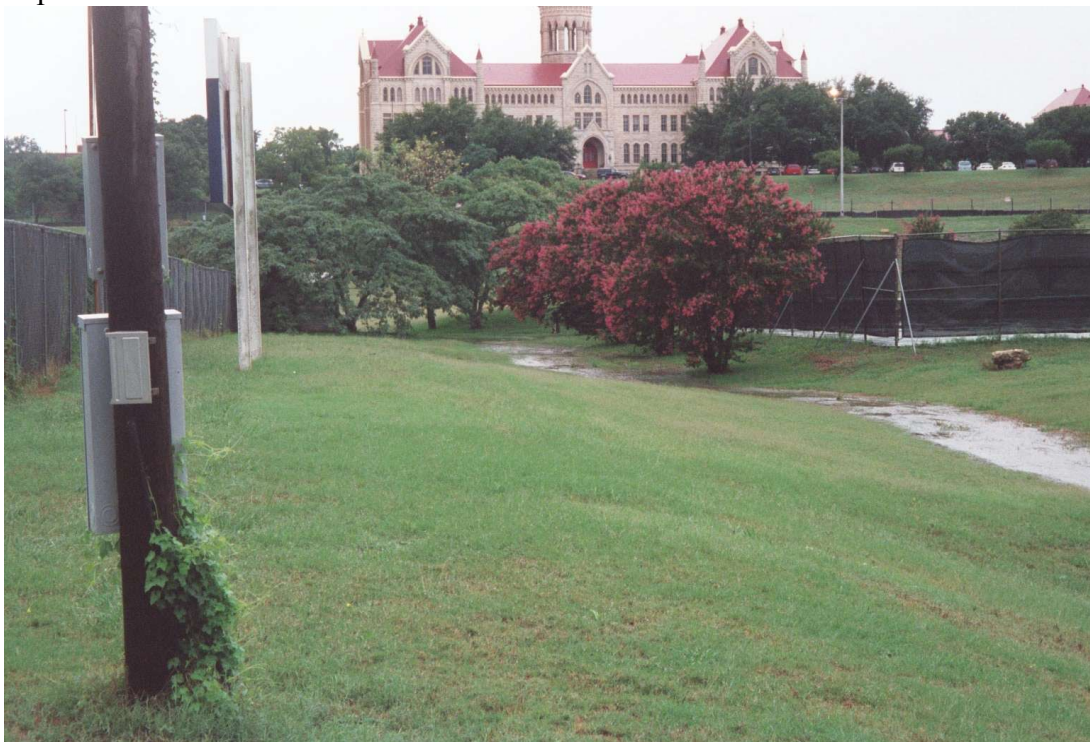
Water had gotten so deep across the road near the phone box that the COA came out and put up barricades.

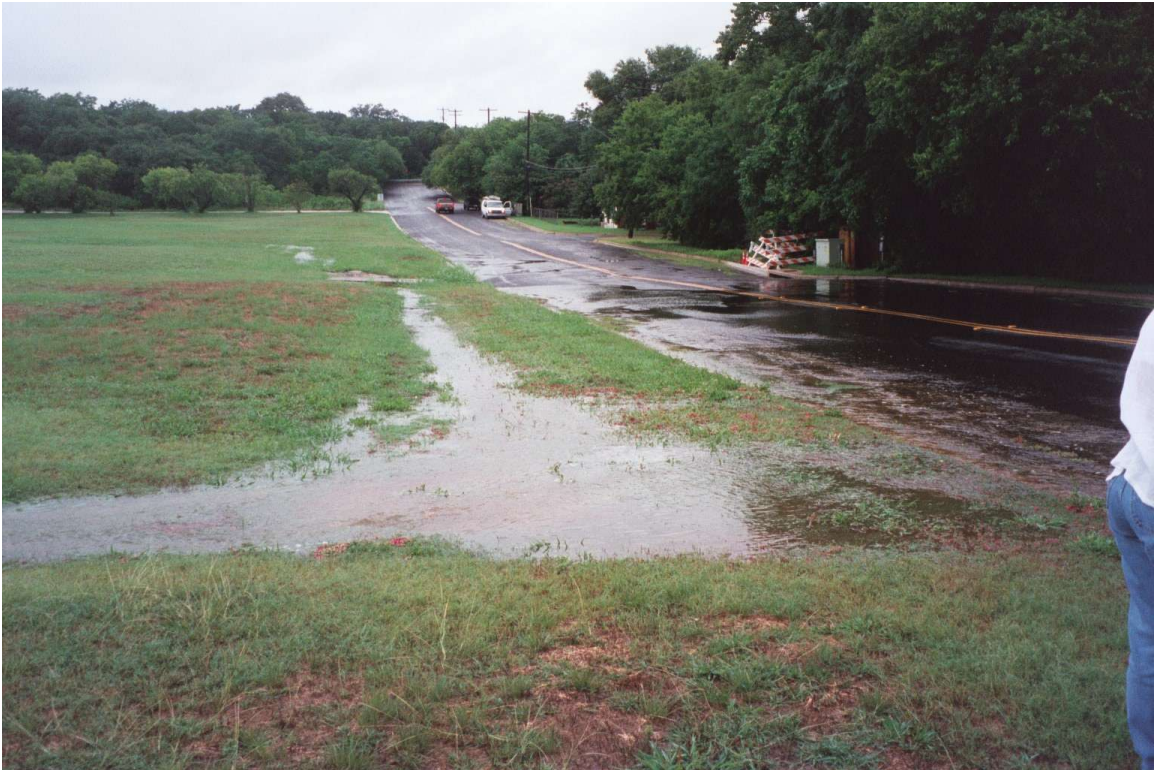
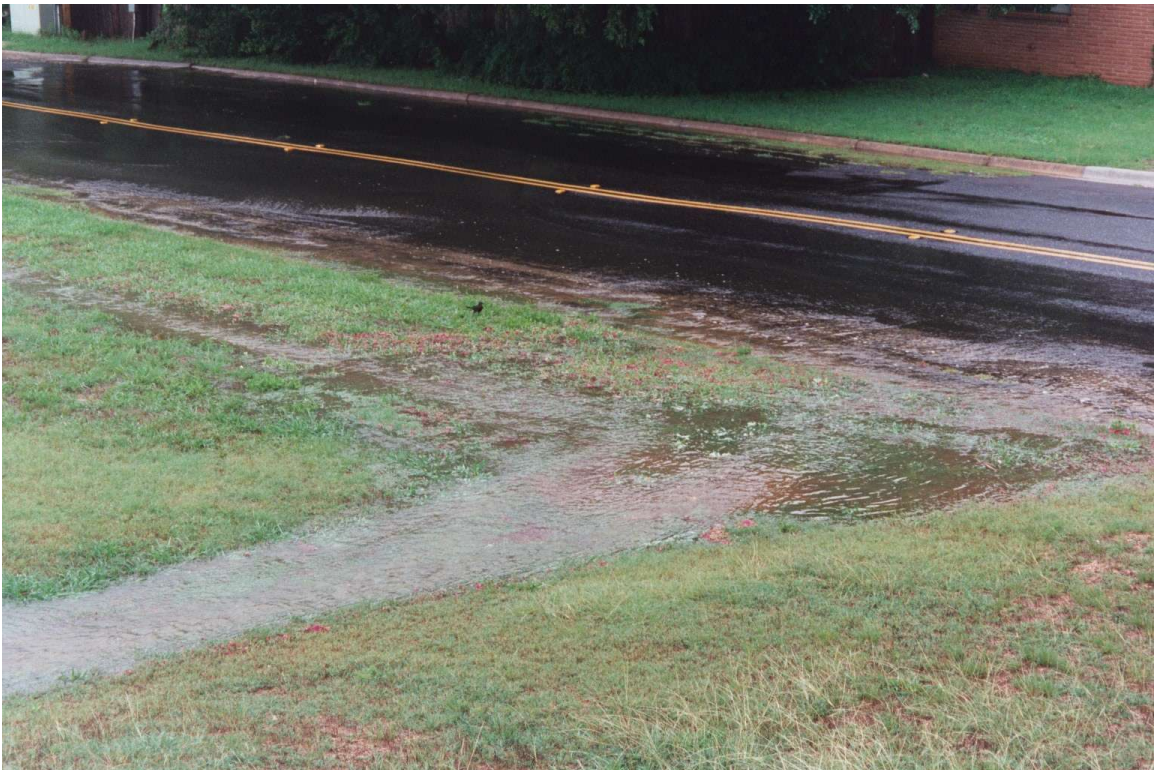
The genesis of the water is from the culvert created by the raised elevation of the baseball field. Runoff from the higher elevations is channeled through this area onto St. Ed's Dr.

Water pools at St. Edward's Drive and crosses the road into the neighborhood.

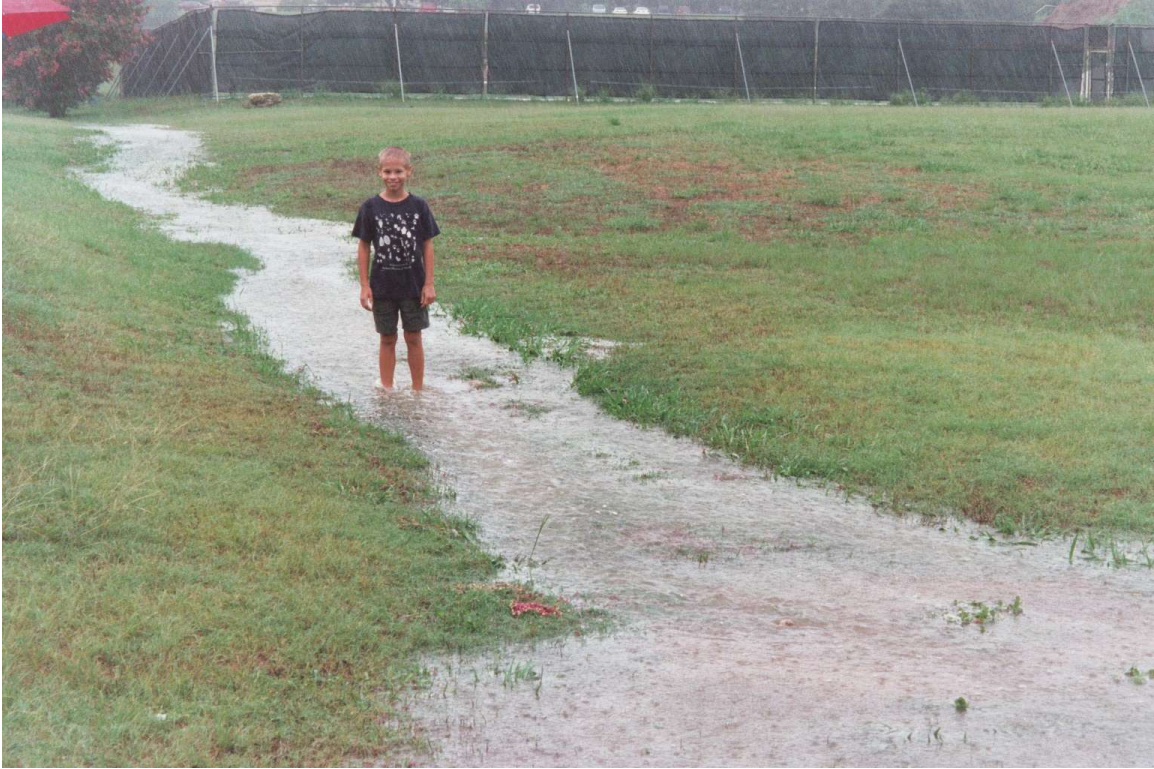
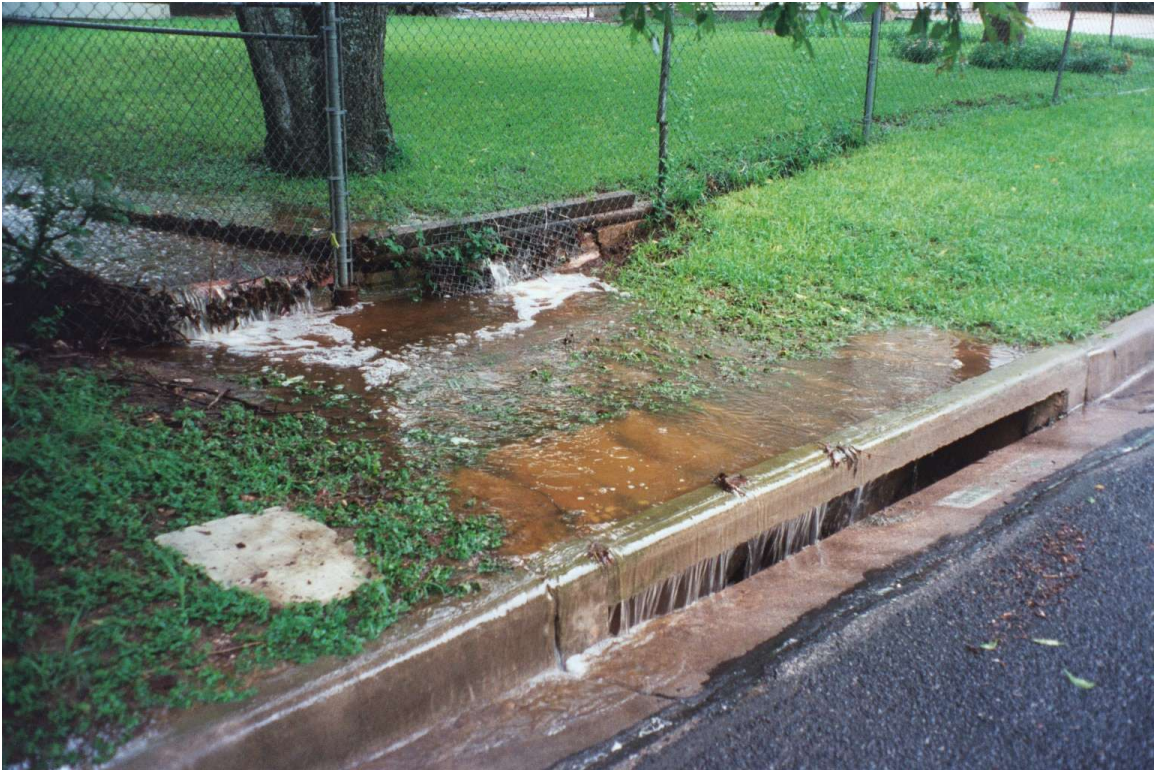
Water that has made it from the St. Edward's property running through the back yards of houses on Friar Tuck Lane to the inlet on Long Bow Lane. This photo is one block further north from the St. Edward's property. One day after the storm.
